Manhole Inspection Summary

Manhole # S07AA2006MH

Insp Date: **9/18/06 10:49 AM**

Location Address: **2705 GLEN AVE** Cross Street: **BERKELEY AVE**

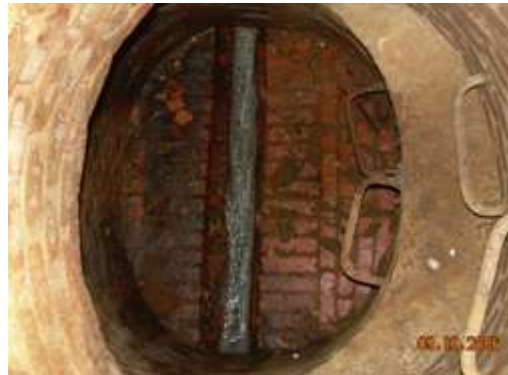
Comments **The Top View picture shows grease deposits in the Channel.**

Adjustment and Barrel infiltration.
Evidence of surcharge - Bench debris.
Corroded steps.

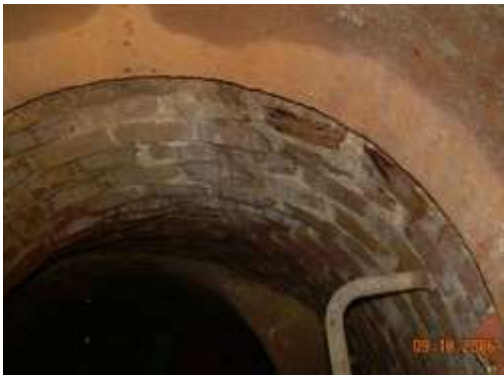
Defect

Frame Offset: **3** (in.) Condition: ☐ Sound ☐ Cracked ☒ **Leaks**

Frame leaks. Adjustment infiltration.

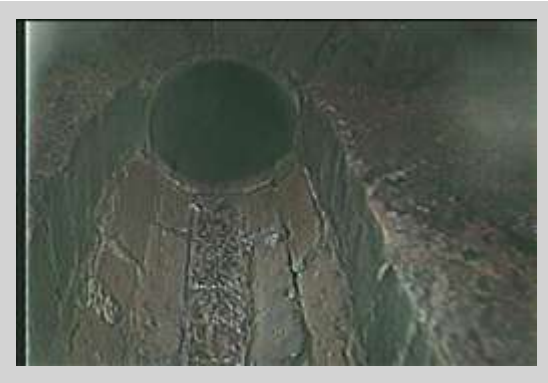
Pipe Out @ 12 O'Clock

Barrel deterioration and infiltration. Channel deterioration.

Infiltration: **Evidence** Pipe Seal Cond: **Unknown**

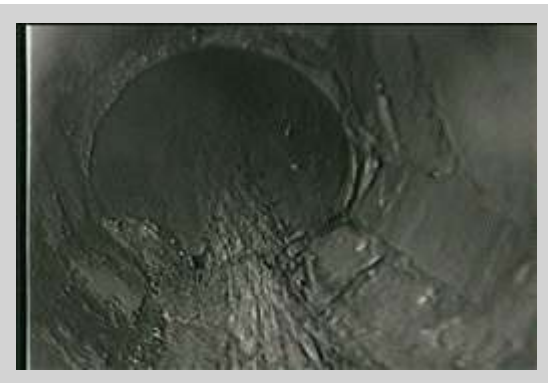
Pipe In @ 6 O'Clock

Infiltration: **Evidence** Pipe Seal Cond: **Cracked**
